COLTON POND DAM

VT 00114

PHASE I INSPECTION REPORT NATIONAL DAM INSPECTION PROGRAM

OCTOBER 1979

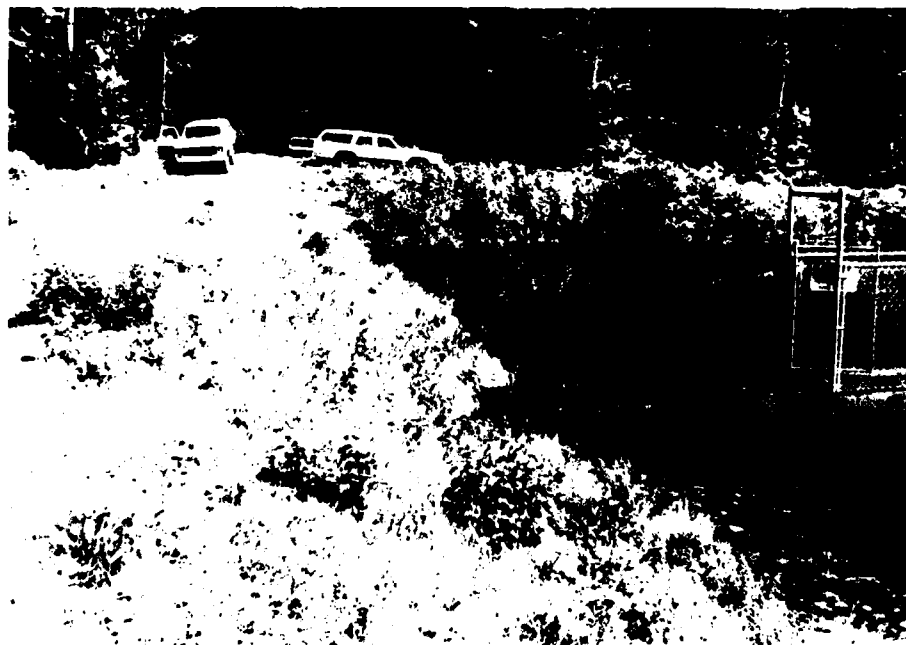
PHOTO NO. 5 - View of right abutment from center of dam.

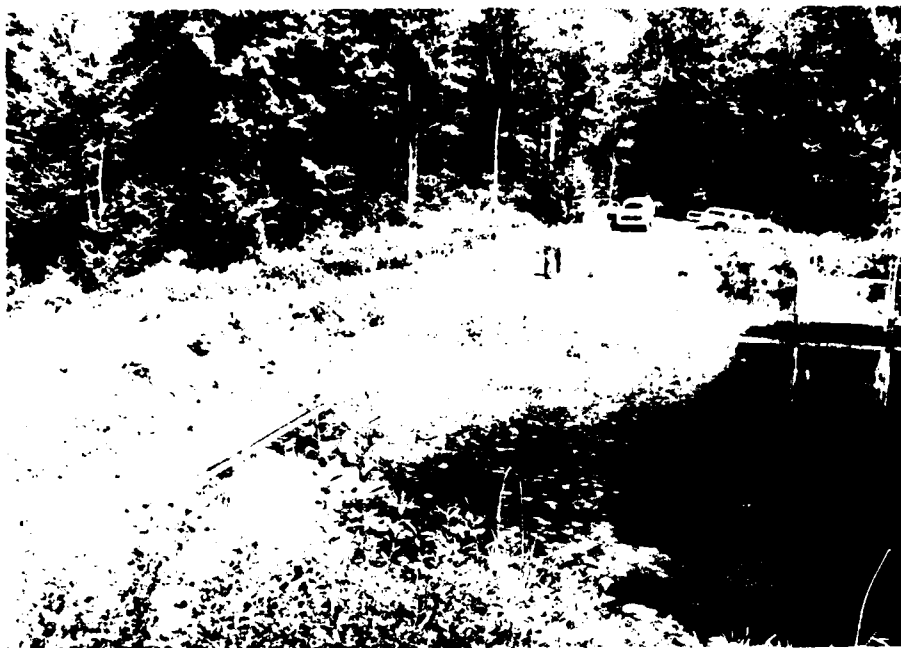
PHOTO NO. 6 - View of dam crest and emergency spillway from left abutment.
